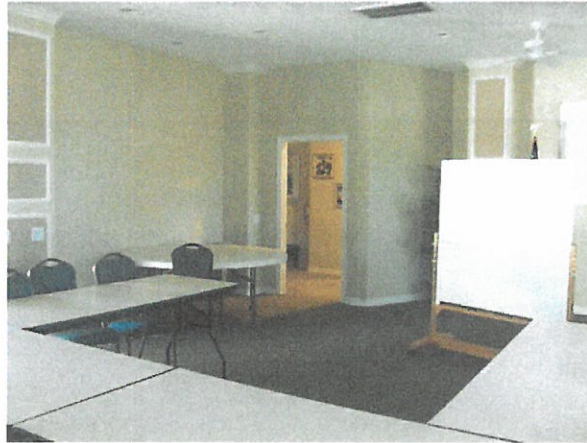
Condition: Good overall

Annex interior overview

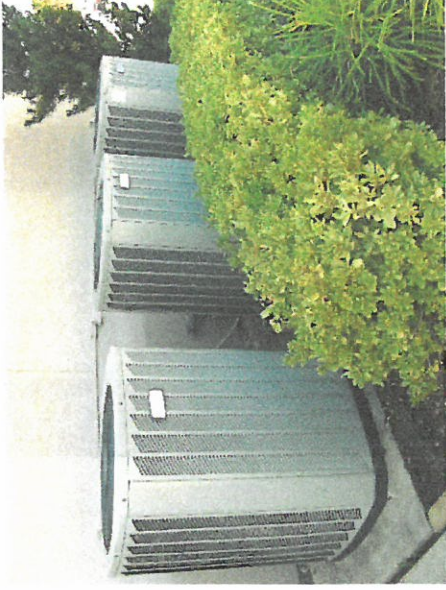
Condition: Reported satisfactory

Condensing units

Expenditure Detail Notes: Expenditure timing and costs are depicted in the **Reserve Expenditures** table in Section 3. The condensing unit may require replacement prior to replacement of the related interior forced air unit. For purposes of this Reserve Study, we assume coordination of replacement of the interior forced air unit, evaporator coil, refrigerant lines and exterior condensing unit.

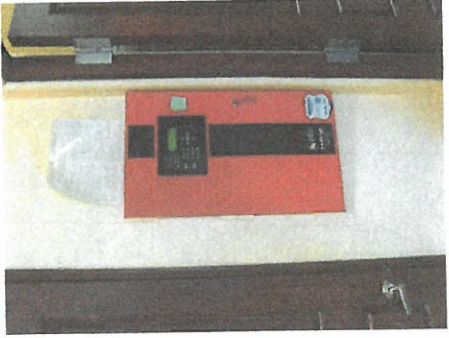
Conditions: Reported satisfactory

Life safety system control panel

Expenditure Detail Notes: Expenditure timing and costs are depicted in the **Reserve Expenditures** table in Section 3. Changes in technology or building codes may make a replacement desirable prior to the end of the functional life. Our estimate of future cost considers only that amount necessary to duplicate the same functionality. Local codes or ordinances at the actual time of replacement may require a betterment as compared to the existing system. A betterment could result in a higher, but at this time unknown, cost of replacement.

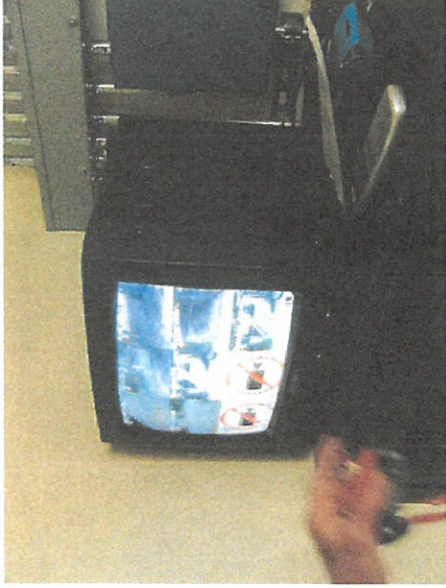
Condition: Reported satisfactory, however concerns with the resolution of the cameras has been reported

Security system monitor at gate house

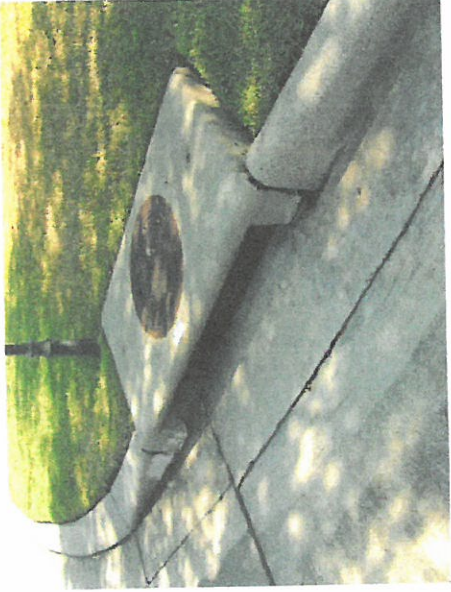
Condition: Good overall without settlement visually apparent

Catch basin

Component Detail Notes: Erosion causes settlement around the collar of catch basins. Left unrepaired, the entire catch basin will shift and need replacement.

Expenditure Detail Notes: Expenditure timing and costs are depicted in the **Reserve Expenditures** table in Section 3. We depict repairs in a phased manner.

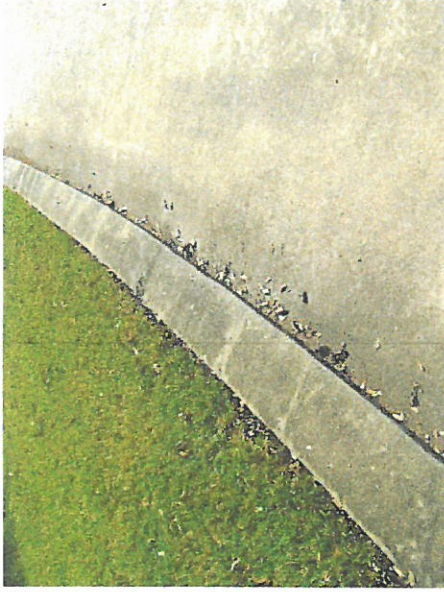
Condition: Good to fair overall with numerous previous repairs and current damage evident

Concrete curbs

Expenditure Detail Notes: Expenditure timing and costs are depicted in the **Reserve Expenditures** table in Section 3. We estimate that up to 6,120 linear feet of curbs, or ten percent (10%) of the total, will require replacement during the next 30 years.

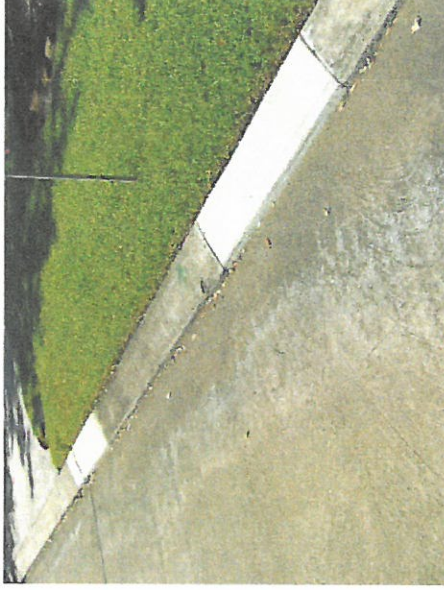
Replaced sections

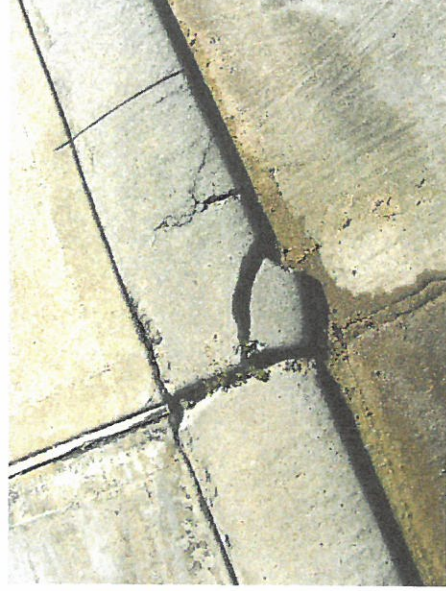
Damaged section

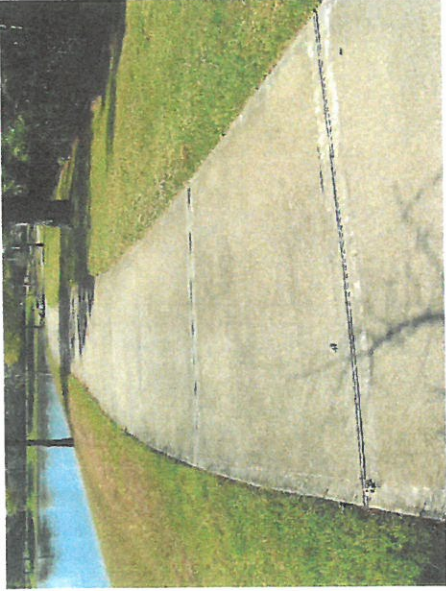
Condition: Good overall with previous repairs evident

Concrete sidewalk

Expenditure Detail Notes: Expenditure timing and costs are depicted in the **Reserve Expenditures** table in Section 3. We estimate that up to 13,500 square feet of concrete sidewalks, or twenty percent (20%) of the total, will require replacement during the next 30 years.

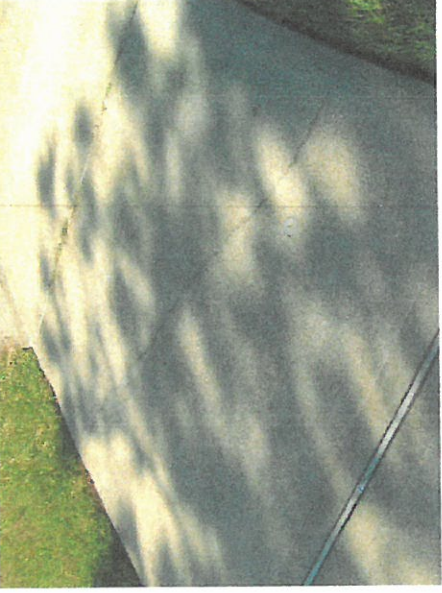
Isolated crack

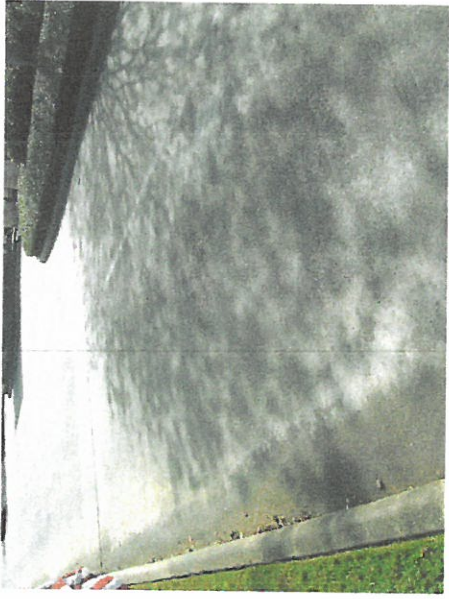
Condition: Good overall with very isolated deterioration evident. We note consistent longitudinal cracks along the middle of the travel lane along Riviera Circle.

Concrete street

Expenditure Detail Notes: Expenditure timing and costs are depicted in the **Reserve Expenditures** table in Section 3. We estimate that up to 106,250 square feet of concrete streets, or thirteen percent (12.5%) of the total, will require replacement during the next 30 years. We depict joint sealant replacement in a phased manner.

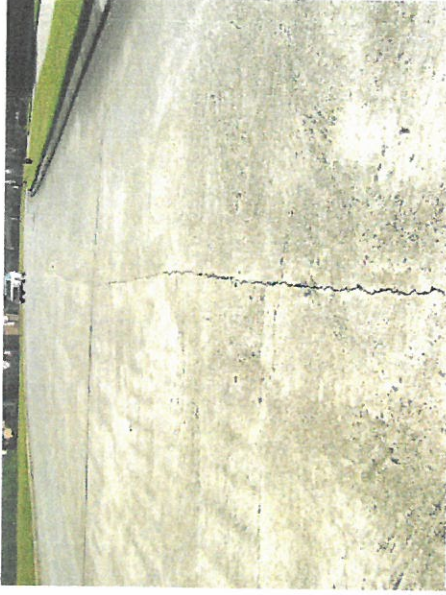
Longitudinal crack

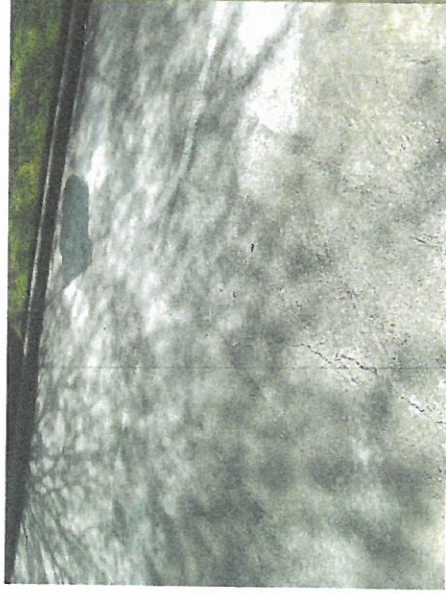
Isolated cracks

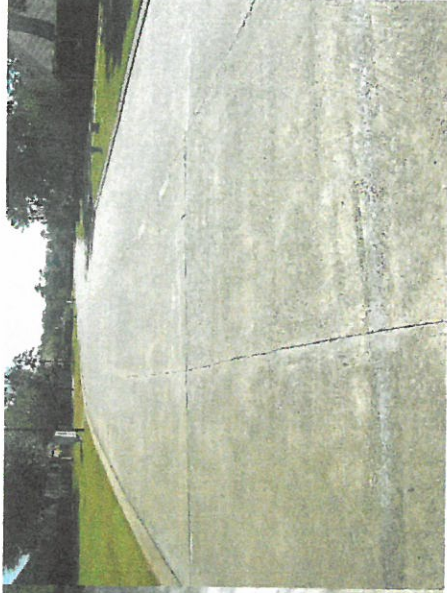
Longitudinal crack

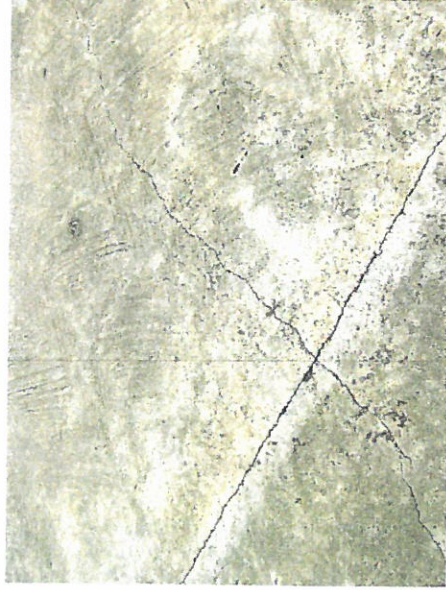
Cracks

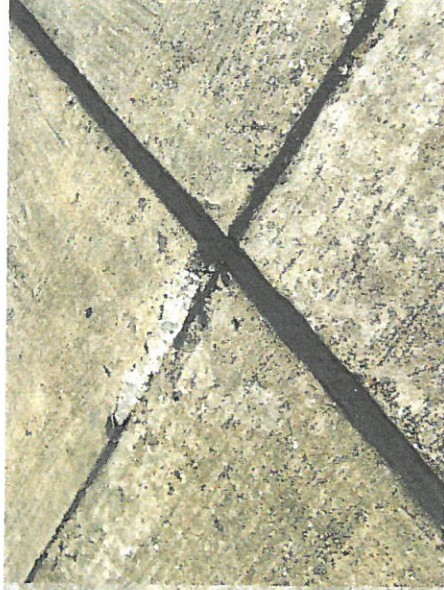
Concrete spall at joint

Component Detail Notes: During cold weather, concrete streets contract causing joints to widen which allows for the accumulation of debris. During warm weather, the pavement expands and the joints narrow. Accumulated incompressible debris in the joints produces high compressive stresses at the adjoining faces of the joints. These compressive stresses can cause spalling of the concrete along the joints. The disintegration and spalling associated with these stresses typically occurs at open, unsealed pavement joints due to moisture and debris accumulation in the joints. For these reasons, we recommend the Association seal all concrete street joints to maximize the useful life of the concrete.

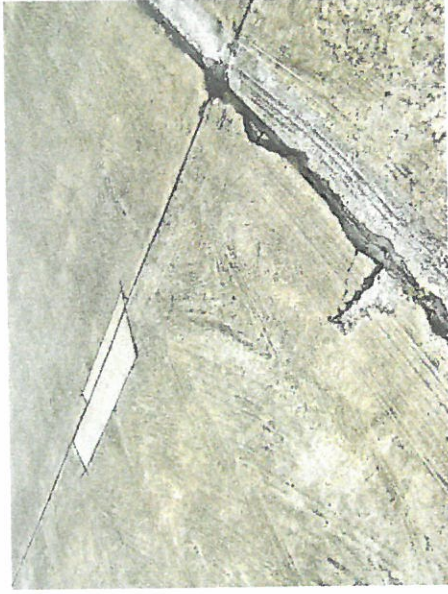
Previous patch and concrete spall at joint

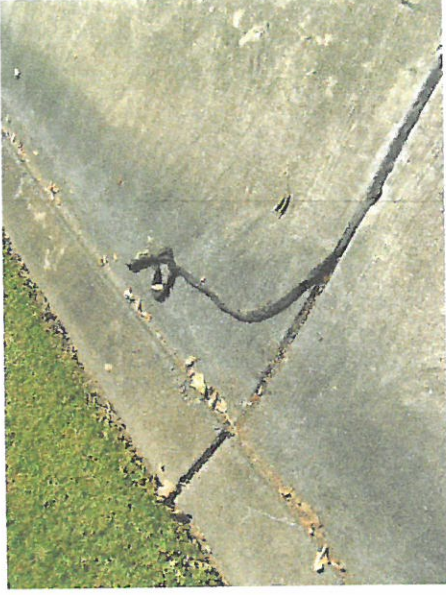
Dislodged joint sealant

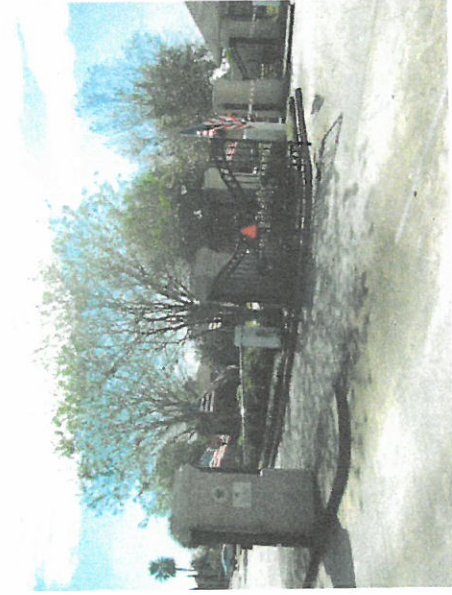
Condition: Good overall

Gates and operators

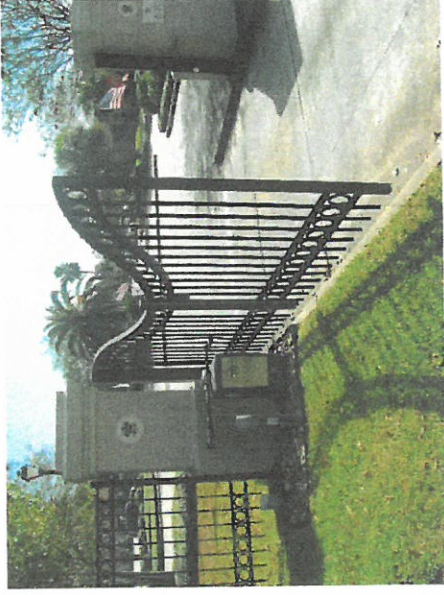
Gate and operator

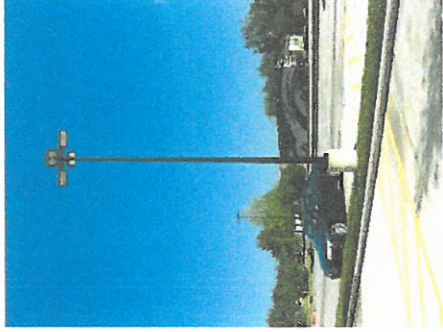
Condition: Good overall

Light pole and fixture

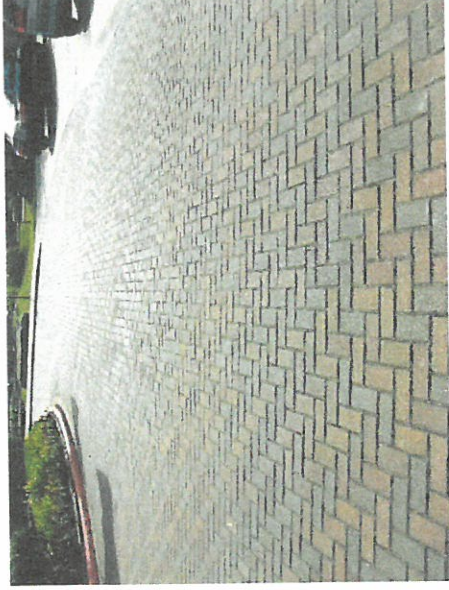
Condition: Good overall

Pavers
